**Flood Control Project Maintenance  
Levee Inspections****LMA District Cover Sheet****Spring 2016 Levee Inspection Results****Marysville Levee Commission**

**Levee Inspection Report By Mile - Spring 2016**

**Marysville Levee Commission**

Waterway	Bank	Unit Miles	Inspection Start/End	Inspector
Unit No. 01 Simmerly Slough	Left	3.23	04/22/2016 04/22/2016	Sterling York

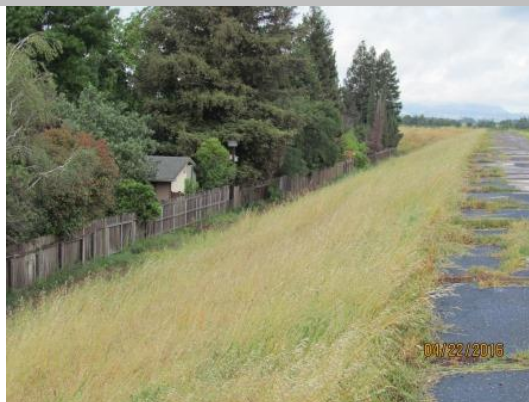
Photo 1 of 1 : SP\_2016\_NA0004\_104\_11\_20160427\_00014.jpg

View of typical vegetation on the landside slope, looking downstream.

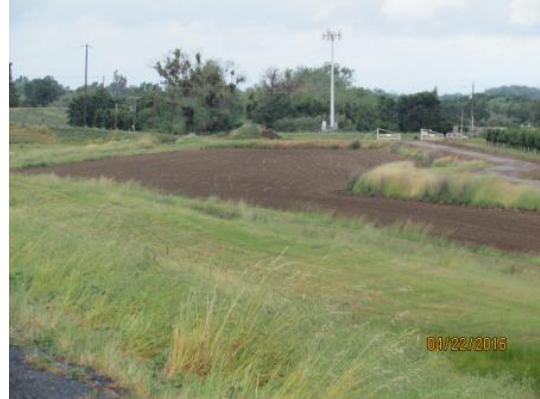
Photo 1 of 1 : SP\_2016\_NA0004\_104\_12\_20160427\_00013.jpg

View of typical vegetation on waterside slope, looking downstream.

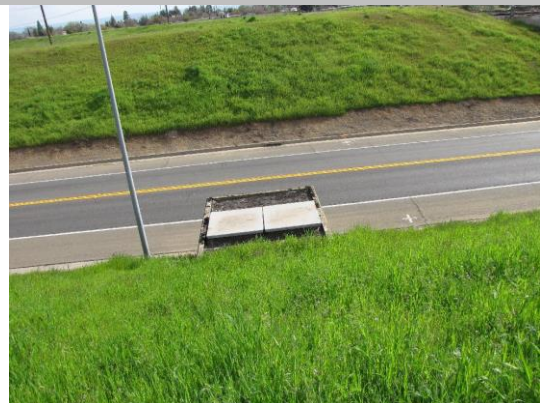
Photo 1 of 2 : UCIP\_SP\_2016\_40931\_69758.jpg

LM Start	0.96	Rating **	M	Issue No.	37
LM End	0.96	Issue Type +	En	Location *	WS
Category	Supplemental			GPS Latitude/Longitude	
				Start	End
Item	DWR UCIP Field Study			39.158946 °	39.158946 °
				-121.589930 °	-121.589930 °
DWR ID					
Comment Code					
Inspector Comment					
FS_ID:40931 DS_ID:19100 EP_NO: 14518 Repair Type: Non-Urgent Crossing Status: Indicator Found UCIP Comments: Recommend having owner removing tall grass along slopes to properly inspect signs of pipe failure. FIELD_STRUCT_DESC: 1 of 2: 10-inch steel pipe through levee, 4.0 feet below crown. Flap gate on waterward end. Concrete vault on waterward shoulder. Metal meter box on the landward shoulder. Pump placed on concrete footings at toe of landward slope. Drainage for underpass. Pipes approx. 2.5-feet apart. (Permit No. 14518-1987). FS Date: 3/14/2013

View of landward side.

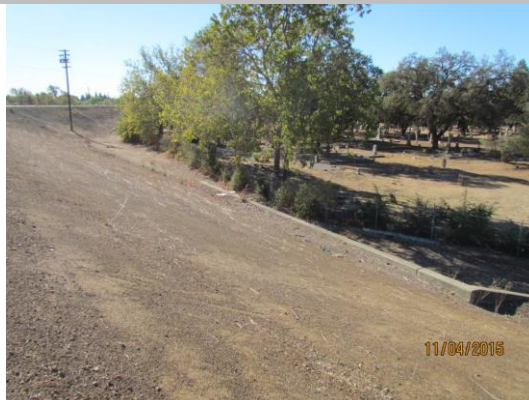
Photo 1 of 1 : SP\_2016\_NA0004\_104\_36\_20160307\_00002.jpg

LM Start	0.97	Rating **	M	Issue No.	36
LM End	0.97	Issue Type +	Ob	Location *	WS
Category	Earthen Levee			GPS Latitude/Longitude	
				Start	End
Item	Encroachments			39.159210 °	39.159210 °
				-121.590033 °	-121.590033 °
DWR ID	DWR_NA0004_01_f_2013_36				
Comment Code					
RW : Retaining Wall					
Inspector Comment					
Concrete retaining wall and toe cut noted by the Corp.

View of the concrete retaining wall at the toe of the levee on the waterward side looking downstream. Fall 2015.

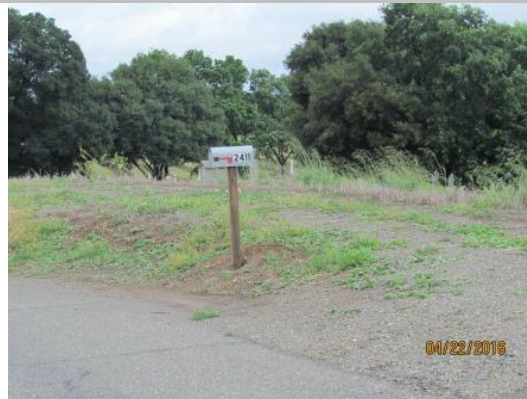
Photo 1 of 1 : SP\_2016\_NA0004\_104\_13\_20160427\_00012.jpg

New post and mail box installed without permit on crown of levee, looking downstream.

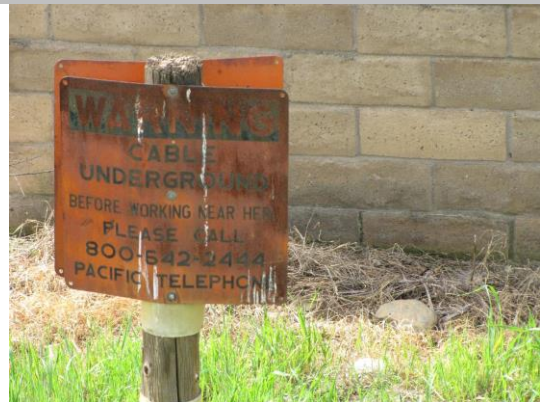
Photo 1 of 2 : UCIP\_SP\_2016\_40935\_69766.jpg

LM Start	3.19	Rating **	M	Issue No.	39	
LM End	3.19	Issue Type +	En	Location *	CR	
Category	Supplemental			GPS Latitude/Longitude		
				Start	End	
Item	DWR UCIP Field Study			39.163888 °	39.163888 °	
				-121.560262 °	-121.560262 °	
DWR ID						
Comment Code						
Inspector Comment						
FS_ID:40935						
DS_ID:19115						
EP_NO: 12878						
Repair Type: Non-Urgent						
Crossing Status: Indicator Found						
UCIP Comments: Need to contact owner to determine additional information about crossing and alignment.						
FIELD_STRUCT_DESC: 24-inch steel pipe encasing 4-inch PVC communications extension through the levee, annular gap grouted, 8 feet below levee crown. Cutoff wall (12x12x20-inch) around extension from levee slopes. (Permit No. 12878-1980).						
FS Date: 3/14/2013

Marker on landward side.

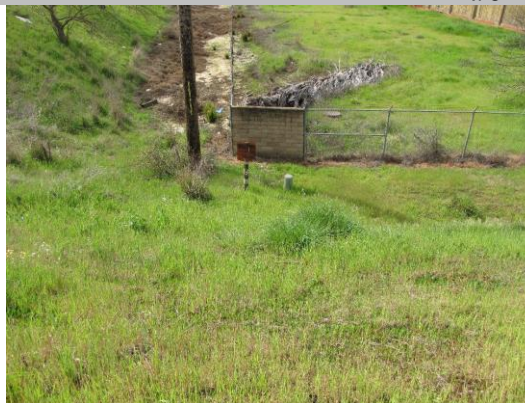
Photo 2 of 2 : UCIP\_SP\_2016\_40935\_69765.jpg

LM Start	3.19	Rating **	M	Issue No.	39 (cont)
LM End	3.19	Issue Type +	En	Location *	CR
Category	Supplemental			GPS Latitude/Longitude	
				Start	End
Item	DWR UCIP Field Study			39.163888 °	39.163888 °
				-121.560262 °	-121.560262 °
DWR ID					
Comment Code					
Inspector Comment					
FS_ID:40935					
DS_ID:19115					
EP_NO: 12878					
Repair Type: Non-Urgent					
Crossing Status: Indicator Found					
UCIP Comments: Need to contact owner to determine additional information about crossing and alignment.					
FIELD_STRUCT_DESC: 24-inch steel pipe encasing 4-inch PVC communications extension through the levee, annular gap grouted, 8 feet below levee crown. Cutoff wall (12x12x20-inch) around extension from levee slopes. (Permit No. 12878-1980).					
FS Date: 3/14/2013

View of landward side.

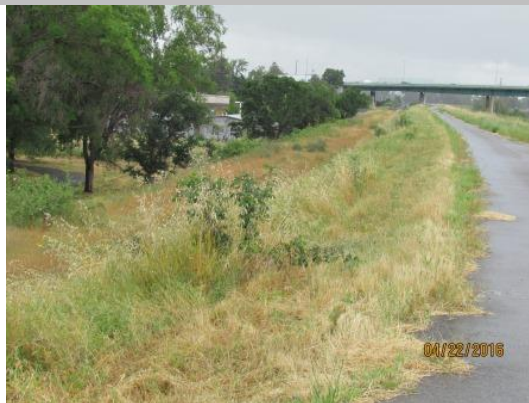
Photo 1 of 1 : SP\_2016\_NA0004\_105\_5\_20160427\_00008.jpg

View looking downstream on the landside of typical vegetation.

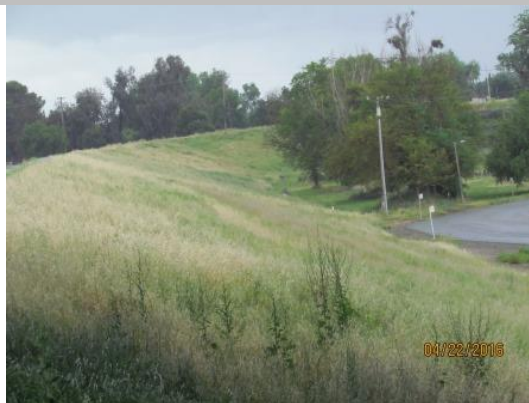
Photo 1 of 1 : SP\_2016\_NA0004\_105\_7\_20160427\_00009.jpg

LM Start	0.00	Rating **	M	Issue No.	7
LM End	1.24	Issue Type +	Ma	Location *	WS
Category	Earthen Levee			GPS Latitude/Longitude	
				Start	End
Item	Vegetation			39.149464 °	39.134686 °
				-121.601093 °	-121.593927 °
DWR ID	DWR_NA0004_02_s _ 2016_7				
Comment Code					
V1 : Control annual grass and weeds on the levee slopes and easements.					
Inspector Comment

View of waterside slope looking downstream of typical vegetation.

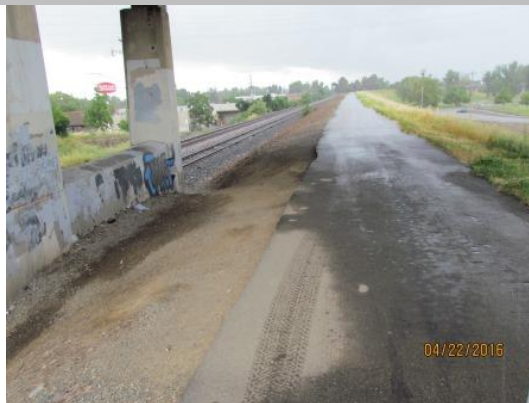
Photo 1 of 1 : SP\_2016\_NA0004\_105\_4\_20160427\_00007.jpg

LM Start	0.32	Rating **	M	Issue No.	4
LM End	0.32	Issue Type +	Ma	Location *	WS
Category	Earthen Levee			GPS Latitude/Longitude	
				Start	End
Item	Slope Stability			39.144840 °	39.144840 °
				-121.600559 °	-121.600559 °
DWR ID	DWR_NA0004_02_s _ 2016_4				
Comment Code					
S2 : Repair the levee slope damaged by foot traffic and prevent access where possible.					
Inspector Comment

View looking downstream of waterside slope erosion due to heavy foot traffic.

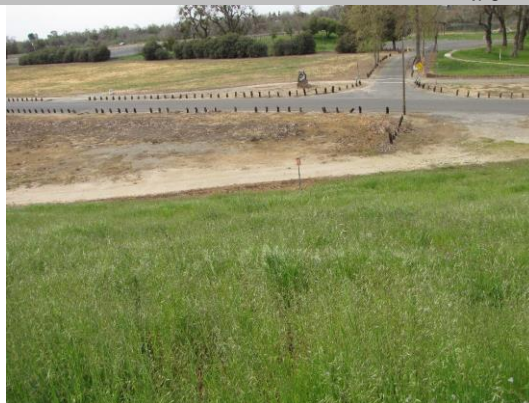
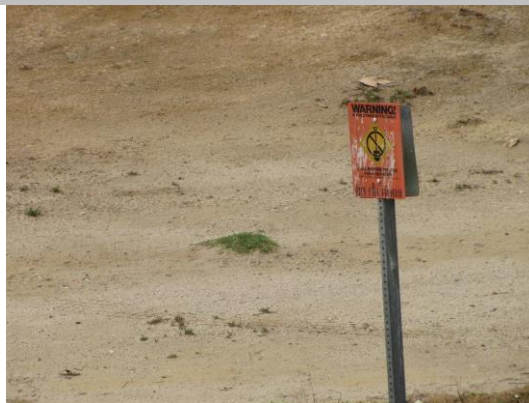
FS\_ID:38272  
DS\_ID:19104  
EP\_NO: N/A  
Repair Type: Non-Urgent  
Crossing Status: Indicator Found  
UCIP Comments: Unable to tell if crossing goes through levee. Need to contact owner to confirm alignment.  
FIELD\_STRUCT\_DESC: 12-inch HDPE conduit, with electrical lines, through the levee. Extends to controller cabinet within the overflow area.  
FS Date: 3/15/2013

View of markers located on waterward toe.

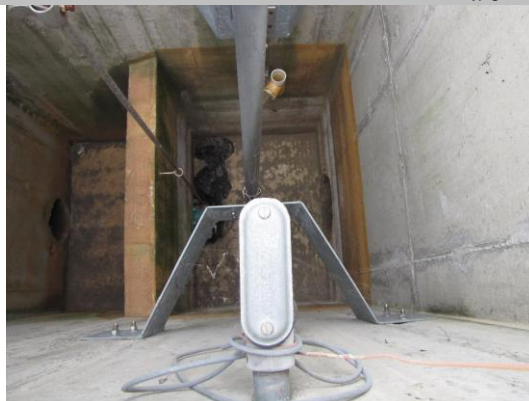
Photo 1 of 2 : UCIP\_SP\_2016\_41024\_72681.jpg

LM Start	0.04	Rating **	M	Issue No.	52
LM End	0.04	Issue Type +	En	Location *	CR
Category	Supplemental			GPS Latitude/Longitude	
				Start	End
Item	DWR UCIP Field Study			39.135010 °	39.135010 °
				-121.593225 °	-121.593225 °
DWR ID					
Comment Code					
Inspector Comment					
FS_ID:41024 DS_ID:25055 EP_NO: N/A Repair Type: Non-Urgent Crossing Status: Found UCIP Comments: Appears that crossing is currently not in use. If crossing is to be abandoned, wwner will need to contact CVFPB to coordinate about proper removal. FIELD_STRUCT_DESC: 10-inch sewer line visible on landward side. According to Marysville Treatment Plant Manager this crossing was installed in 1995-1996. Coordinates for box located on landward side: 39.135185, -121.593254. Note coordinates used for levee crossing are projected coordinates. FS Date: 3/14/2013

Inside view of concrete box.

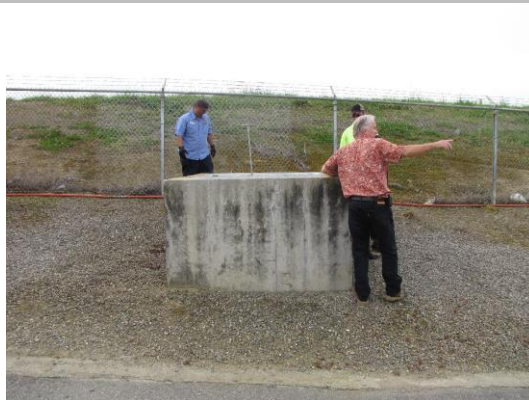
Photo 2 of 2 : UCIP\_SP\_2016\_41024\_72680.jpg

View of concrete box located on landward side--crossing not in use according to Marysville Sewage Treatment Plant Manager.

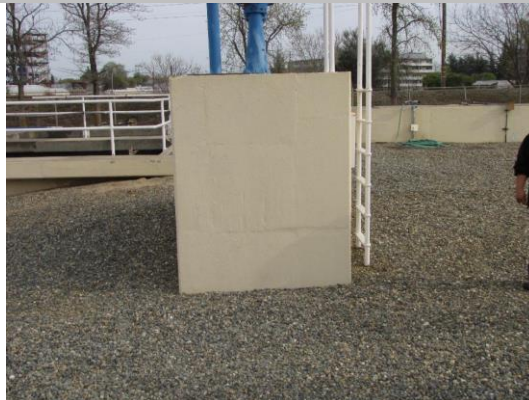
Photo 2 of 2 : UCIP\_SP\_2016\_41025\_69811.jpg

LM Start	0.07	Rating **	M	Issue No.	53
LM End	0.07	Issue Type +	En	Location *	CR
Category	Supplemental			GPS Latitude/Longitude	
				Start	End
Item	DWR UCIP Field Study			39.135090 °	39.135090 °
				-121.592663 °	-121.592663 °
DWR ID					
Comment Code					
Inspector Comment					
FS_ID:41025 DS_ID:19126 EP_NO: N/A Repair Type: Non-Urgent Crossing Status: Found UCIP Comments: Owner will need to coordinate with DWR-Inspector and CVFPB to determine if crossing meets Title 23 requirements for proper abandonment. FIELD_STRUCT_DESC: Abandoned 24-inch diameter outfall line through levee, under Permit No. 4714 (1963). Pipe completely grouted in levee section, cut at slopes. Coordinates for box located on landward side: 39.135259, -121.592593. Note coordinates used for levee crossing are projected coordinates. FS Date: 3/15/2013

Standpipe where old line is still located.

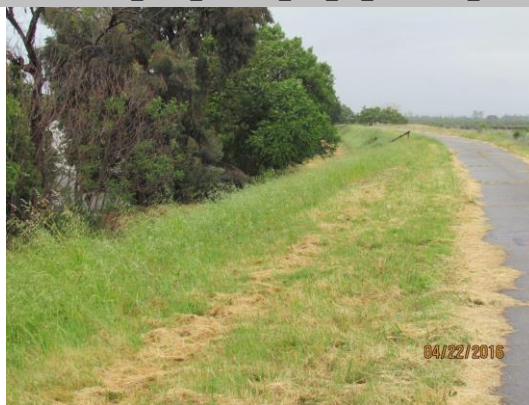
Photo 1 of 1 : SP\_2016\_NA0004\_106\_29\_20160427\_00043.jpg

View of typical vegetation on landside slope, looking upstream.

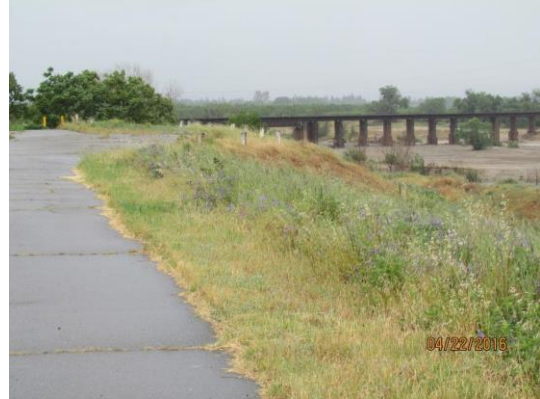
Photo 1 of 1 : SP\_2016\_NA0004\_106\_30\_20160427\_00042.jpg

View of vegetation on the waterside slope looking upstream.

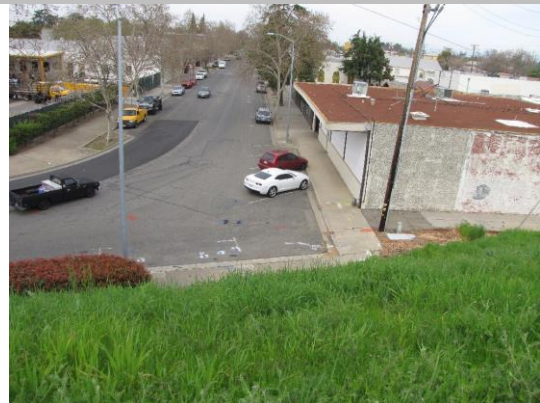
Photo 1 of 2 : UCIP\_SP\_2016\_40969\_72683.jpg

LM Start	0.47	Rating **	M	Issue No.	54
LM End	0.47	Issue Type +	En	Location *	WS
Category	Supplemental			GPS Latitude/Longitude	
				Start	End
Item	DWR UCIP Field Study			39.135932 °	39.135932 °
				-121.585529 °	-121.585529 °
DWR ID					
Comment Code					
Inspector Comment					
FS_ID:40969					
DS_ID:19133					
EP_NO: 1983					
Repair Type: Non-Urgent					
Crossing Status: Indicator Found					
UCIP Comments: Need to contact owner. Unable to determine if crossing is still in use.					
FIELD_STRUCT_DESC: 3/4-inch water line through the levee. Water meter at landward toe. Extends from nearby buildings, bunkers, suction dredge on waterward side. (Permit No. 1983-1959).					
FS Date: 3/15/2013

Underground service alert (USA) blue paint indicators of water line present on landward side.

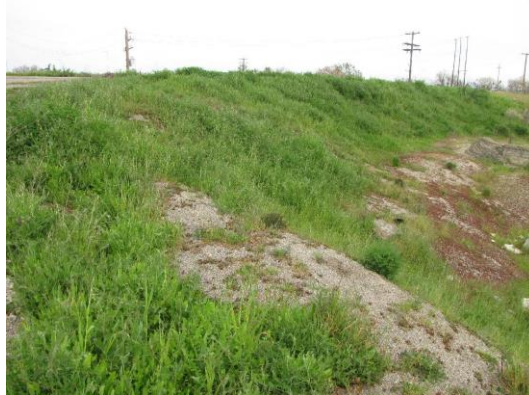
Photo 2 of 2 : UCIP\_SP\_2016\_40969\_72682.jpg

LM Start	0.47	Rating **	M	Issue No.	54 (cont)	
LM End	0.47	Issue Type +	En	Location *	WS	
Category	Supplemental			GPS Latitude/Longitude		
				Start	End	
Item	DWR UCIP Field Study			39.135932 °	39.135932 °	
				-121.585529 °	-121.585529 °	
DWR ID						
Comment Code						
Inspector Comment						
FS_ID:40969						
DS_ID:19133						
EP_NO: 1983						
Repair Type: Non-Urgent						
Crossing Status: Indicator Found						
UCIP Comments: Need to contact owner. Unable to determine if crossing is still in use.						
FIELD_STRUCT_DESC: 3/4-inch water line through the levee. Water meter at landward toe. Extends from nearby buildings, bunkers, suction dredge on waterward side. (Permit No. 1983-1959).						
FS Date: 3/15/2013

View of waterward slope--unable to confirm if crossing is active--line buried.

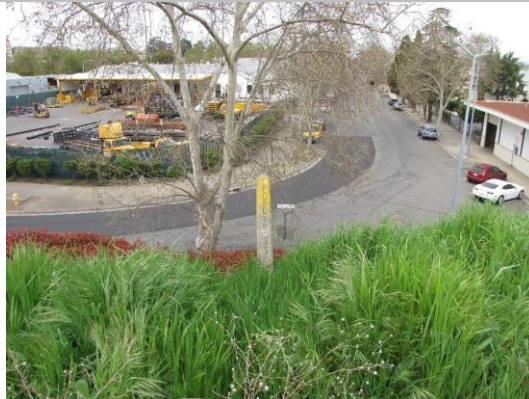
Photo 1 of 2 : UCIP\_SP\_2016\_42048\_72686.jpg

LM Start	0.48	Rating **	U	Issue No.	43
LM End	0.48	Issue Type +	En	Location *	WS
Category	Supplemental			GPS Latitude/Longitude	
				Start	End
Item	DWR UCIP Field Study			39.135976 °	39.135976 °
				-121.585434 °	-121.585434 °
DWR ID					
Comment Code					
Inspector Comment					
FS_ID:42048 DS_ID:19134 EP_NO: N/A Repair Type: Urgent Crossing Status: Indicator Found UCIP Comments: Need to contact owner to determine status of crossing. Need date of last inspection and confirmation that crossing is still in operable condition.Frank Miller Marysville Levee Commission.To whom it may concern, Marysville Levee Commission is in process of drafting a letter to determine owner as well as determine line status, wether active or non-active as well as cordinates. FIELD_STRUCT_DESC: 8-inch high pressure gas line along landward toe. FS Date: 3/15/2013

View of landward side.

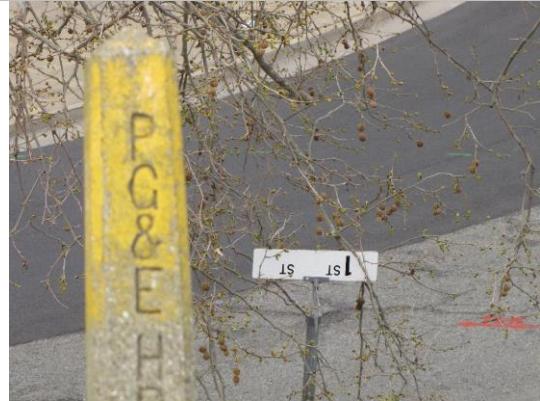
Photo 2 of 2 : UCIP\_SP\_2016\_42048\_72685.jpg

LM Start	0.48	Rating **	U	Issue No.	43 (cont)
LM End	0.48	Issue Type +	En	Location *	WS
Category	Supplemental			GPS Latitude/Longitude	
				Start	End
Item	DWR UCIP Field Study			39.135976 °	39.135976 °
				-121.585434 °	-121.585434 °
DWR ID					
Comment Code					
Inspector Comment					
FS_ID:42048 DS_ID:19134 EP_NO: N/A Repair Type: Urgent Crossing Status: Indicator Found UCIP Comments: Need to contact owner to determine status of crossing. Need date of last inspection and confirmation that crossing is still in operable condition.Frank Miller Marysville Levee Commission.To whom it may concern, Marysville Levee Commission is in process of drafting a letter to determine owner as well as determine line status, wether active or non-active as well as coordinates. FIELD_STRUCT_DESC: 8-inch high pressure gas line along landward toe. FS Date: 3/15/2013

PG&E gas line

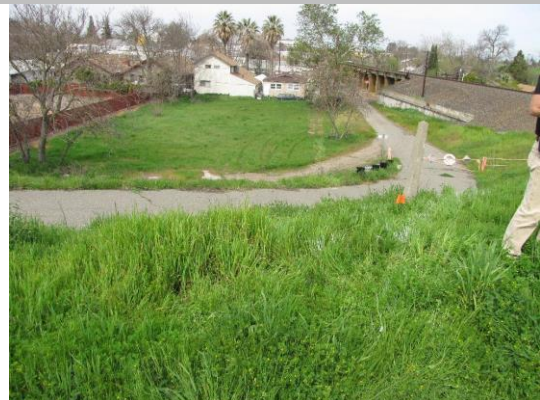
Photo 1 of 2 : UCIP\_SP\_2016\_42049\_72702.jpg

LM Start	0.55	Rating **	U	Issue No.	44
LM End	0.55	Issue Type +	En	Location *	WS
Category	Supplemental			GPS Latitude/Longitude	
				Start	End
Item	DWR UCIP Field Study			39.136348 °	39.136348 °
				-121.584171 °	-121.584171 °
DWR ID

View of landward side--underground alert service (USA) flags visible on landward shoulder.

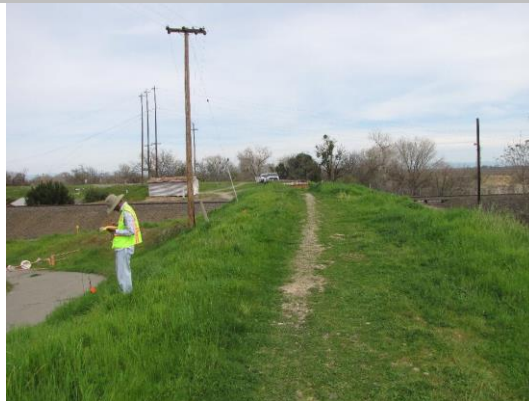
Photo 2 of 2 : UCIP\_SP\_2016\_42049\_72700.jpg

View of levee crown.

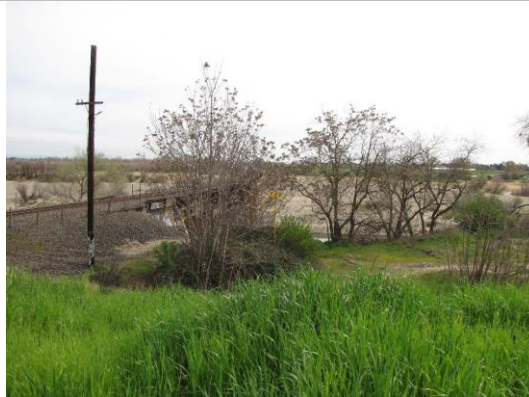
Photo 1 of 2 : UCIP\_SP\_2016\_42051\_72690.jpg

View of waterward side--marker visible inside channel.

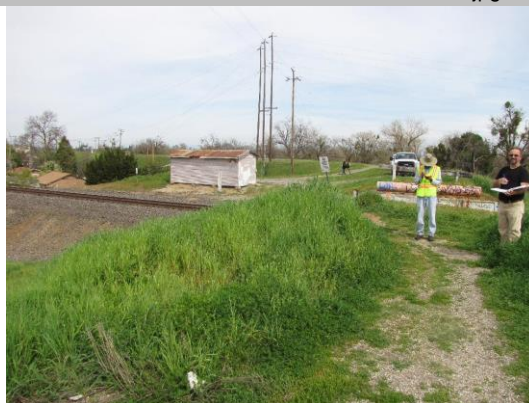
Photo 2 of 2 : UCIP\_SP\_2016\_42051\_72689.jpg

View of upstream levee.

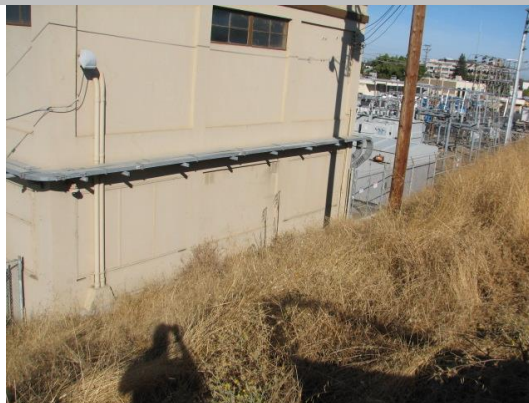
Photo 1 of 1 : SP\_2016\_NA0004\_106\_4\_20160307\_00002.jpg

Building encroaching at landside levee toe.

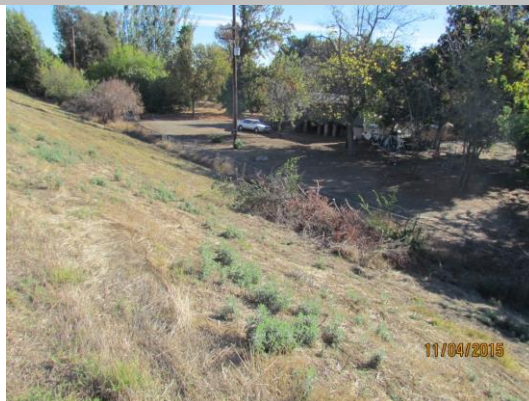
Photo 1 of 1 : SP\_2016\_NA0004\_106\_31\_20160307\_00008.jpg

View of the pile of prunings on the waterward side of the levee looking upstream. Fall 2015.

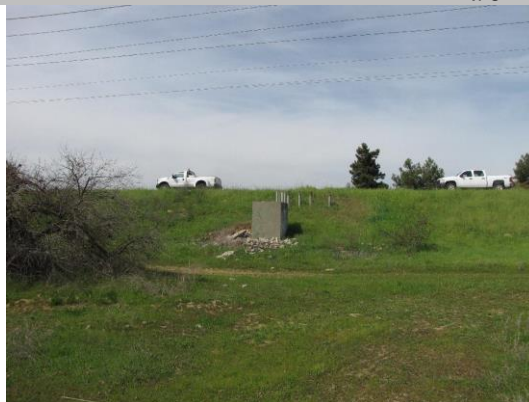
Photo 2 of 2 : UCIP\_SP\_2016\_40999\_69829.jpg

View of waterward side--concrete box and vent pipes located on waterward slope.

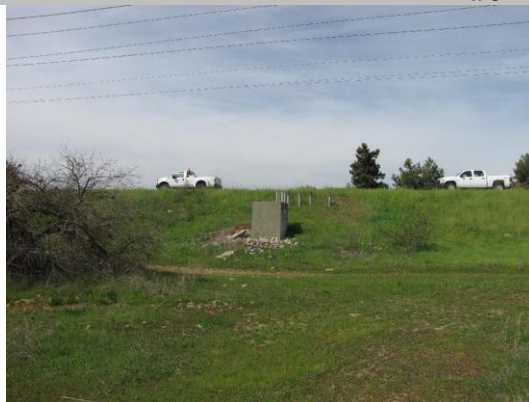
Photo 2 of 2 : UCIP\_SP\_2016\_40998\_69834.jpg

Concrete box and vent pipes located on waterward slope.

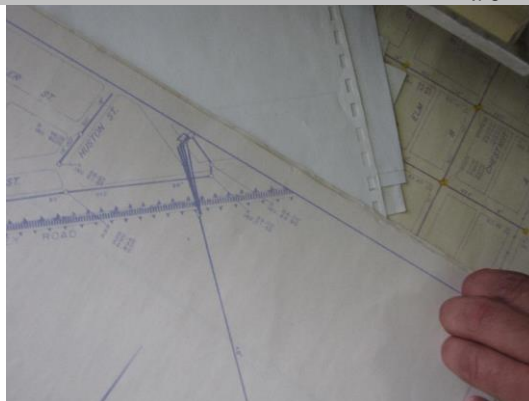
Photo 1 of 2 : UCIP\_SP\_2016\_41001\_69821.jpg

City of Marysville Wastewater Treatment Facility records indicating multiple crossings through levee.

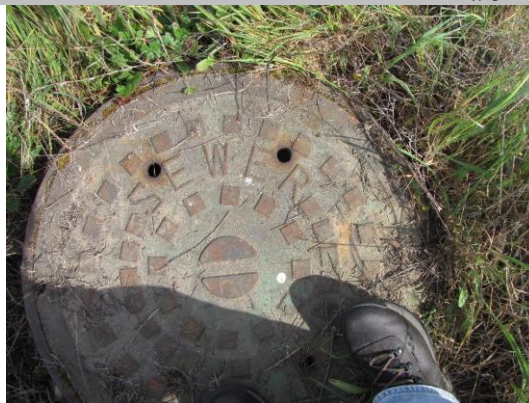
Photo 1 of 2 : UCIP\_SP\_2016\_41002\_25149.jpg

Manhole located on landward toe.

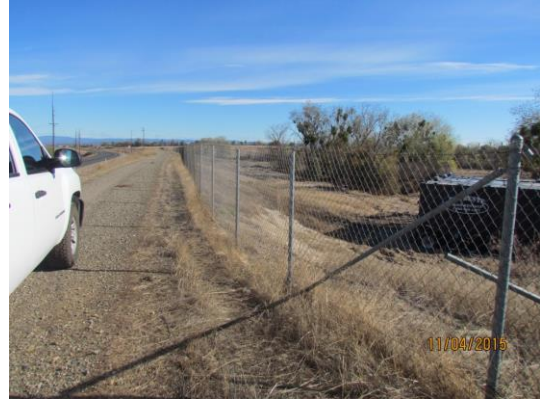
Photo 1 of 1 : SP\_2016\_NA0004\_106\_28\_20160307\_00007.jpg

View of the fence on the waterward shoulder of the levee looking upstream. Fall 2015.

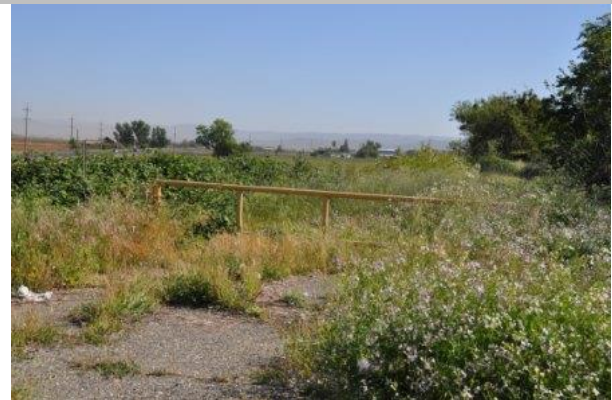
Photo 1 of 1 : SP\_2016\_NA0004\_106\_1\_20160307\_00001.jpg

Marysville, Unit 3 - Spring 2013 - Patrol road vegetation.

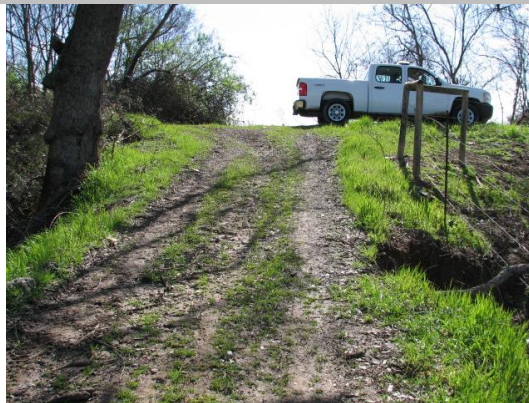
Photo 1 of 1 : SP\_2016\_NA0004\_106\_10\_20160307\_00005.jpg

This ramp is on the patrol road, no known permit.
